Village Handpump Technology

Research and Evaluation in Asia

Village handpump technology : research and evaluation in Asia.
Ottawa, Ont., IDRC, 1982. 72 p. : ill.

Editors: Donald Sharp and Michael Graham

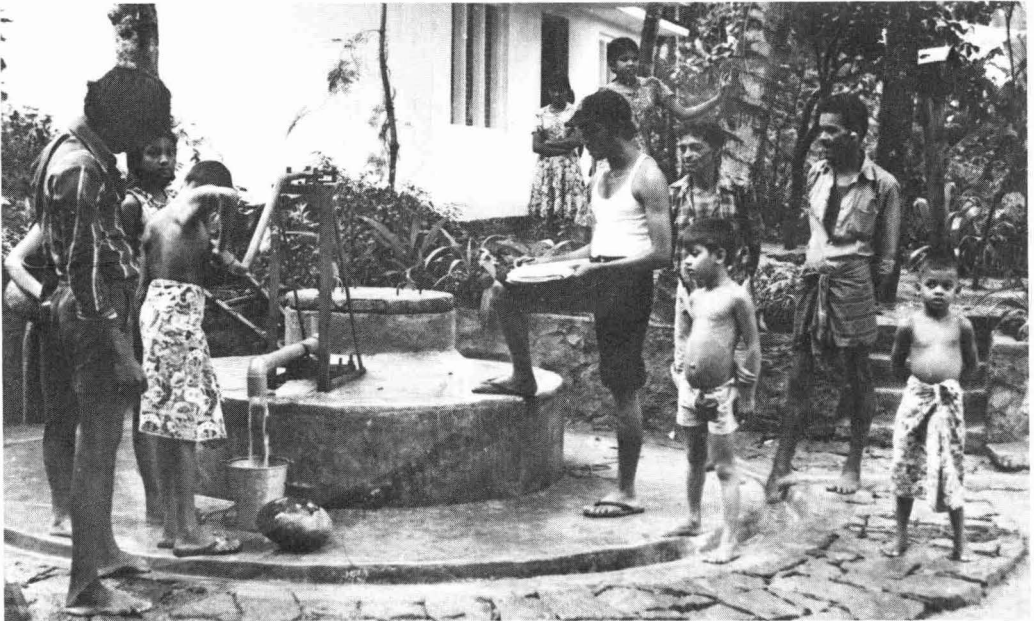
Fig. 1. View of well showing drainage channel to remove spilled water and stone layer to assist drainage.
